Existing Structural Conditions Report

This report describes the existing condition of the structure of Fort River Elementary School as relevant to the potential school renovation project.

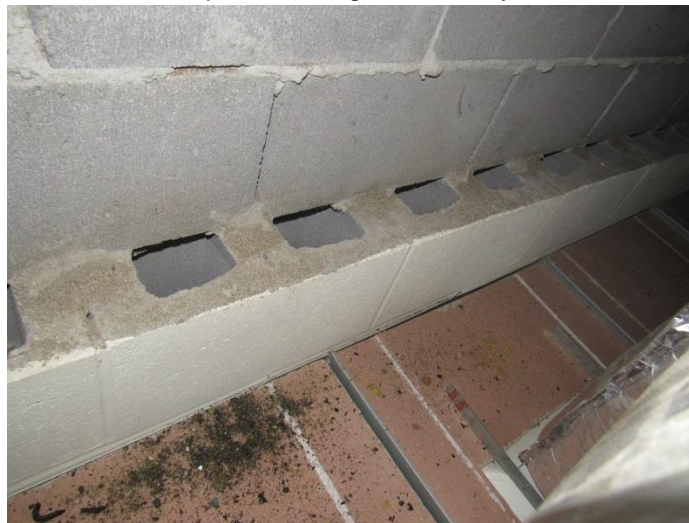
Figure 1 – CMU Walls are ungrouted and unreinforced.

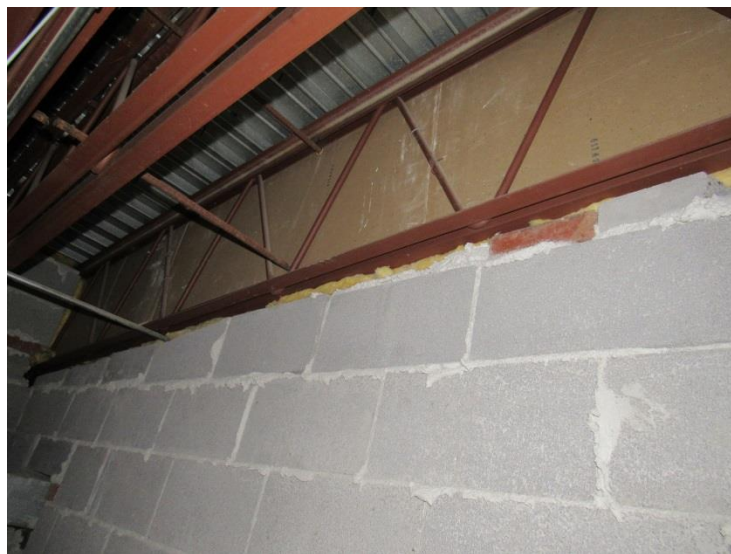
The lateral load resisting system is not explicitly stated in the 1971 drawings. The steel frame is not detailed as a lateral load resisting moment frame and no steel braces are provided. We suspect that the majority of the lateral loading is carried by the 8" thick CMU infill walls that are provided between beams and columns throughout the building. However, these walls do not appear to be detailed as shear walls. The CMU cells are not grouted or reinforced as shown in Figure 1. In many areas, the top of the CMU walls lack engagement to the beams and trusses above as shown in Figure 2. Thus, there is no engagement between the diaphragm and the CMU walls.

Figure 2 – Gap between top of CMU walls and steel structure

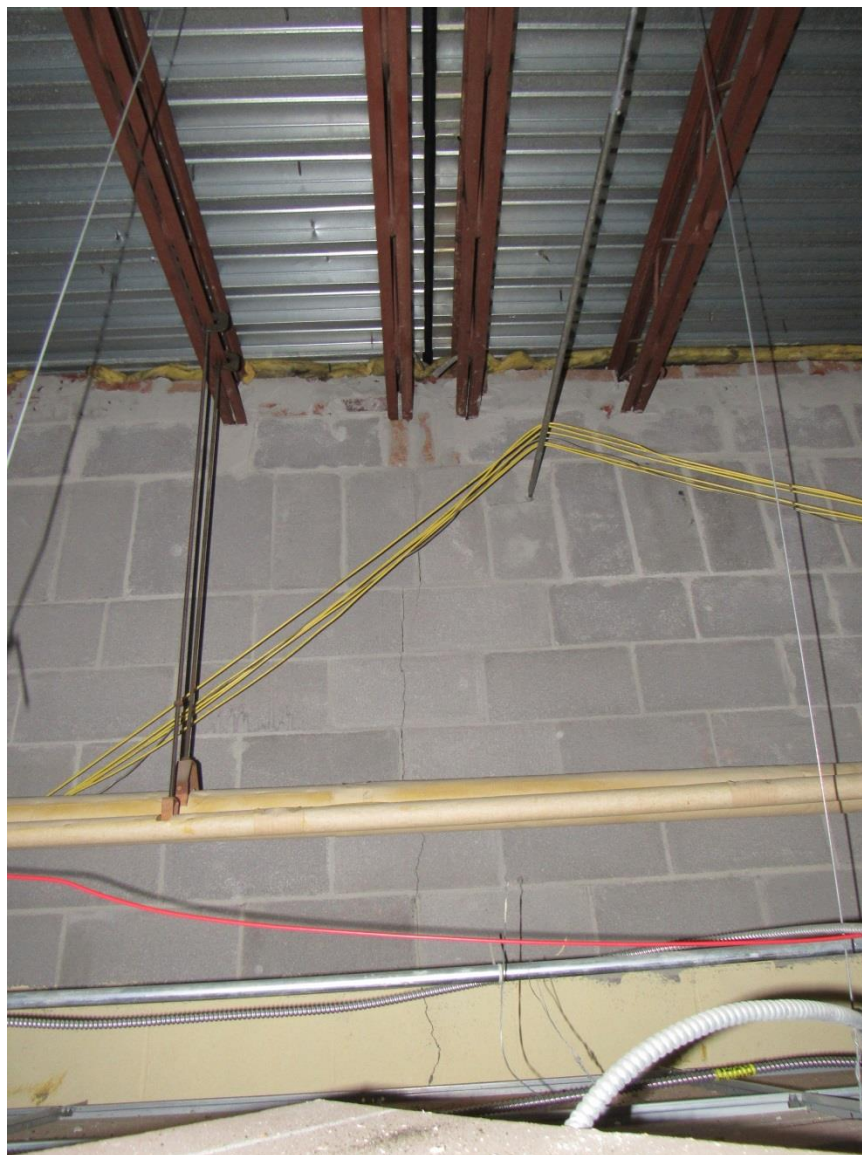
- 1) Expansion joint is provided in the steel roof structure, but not in the CMU infill wall. The CMU infill wall is cracking due to missing expansion joint. This is a cosmetic defect as the CMU wall is non-bearing.

Figure 3 – Crack in CMU wall is cosmetic and not a structural concern.

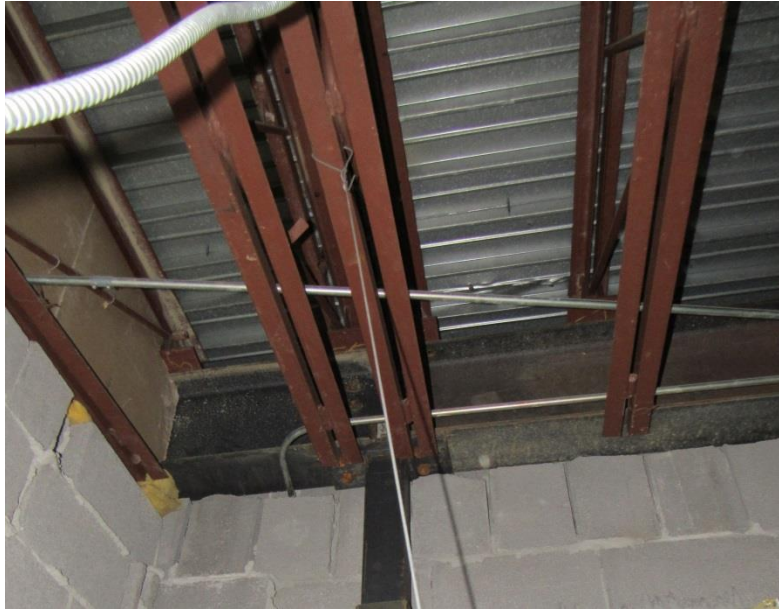
- 2) The steel deck, open web joists, girders, and columns appeared to be in very good condition. There are no signs of corrosion or deterioration from the locations above removed ceiling tiles.

Figure 4 – Steel framing appears to be in excellent condition

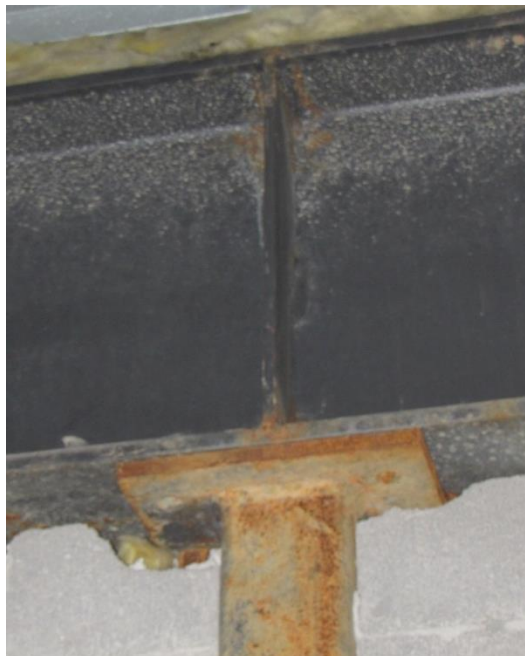
- 3) The bolts are missing in this beam to column connection near gridline C-10. Bolts shall be replaced in all instances where a positive connection is missing.

Figure 5 – Bolts Missing in Beam Column connection
