Enos Cook Memorial Fountain Assessment Report

Town of Amherst
Sweetser Park
Amherst, MA 01002

November 2018

ENGINEER'S REPORT

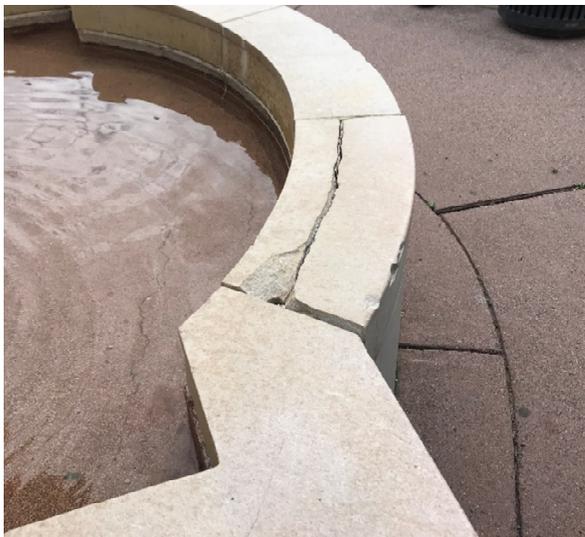
The existing condition of the fountain is poor. As previously mentioned, the fountain has not seen any significant renovations since 1995. There is significant cracking along the basin floor, veneer, coping and along the centerpiece column. The cement caulking along the basin veneer and coping has become detached, creating large openings along the basin (See **Figure C** and **Figure D**). It was noted by the Town that water depths in the fountain are kept low to avoid seepage through the cracks and openings.

Figure C– Cracking along Basin Siding

The cracks and openings along the fountain basin and fountain centerpiece are significant. Water is most likely seeping into these cracks and openings impacting the structural integrity of the fountain. The cement caulking holding pieces of the fountain together has loosened. If this binding continues to loosen it could pose a hazard to people visiting the fountain by pieces falling off creating a trip hazard or water leaking from the fountain creating a slip hazard.

The existing condition of the fountain is poor. Repairing the fountain to bring it back to “like new” conditions does not seem to be a feasible solution. It is recommended that the fountain be replaced. Per the Town’s instruction, the design of the fountain cannot deter from the original Olmstead Brothers’ design. Since the fountain design is unique the Town would need to work with a manufacturing company to create a custom fountain.

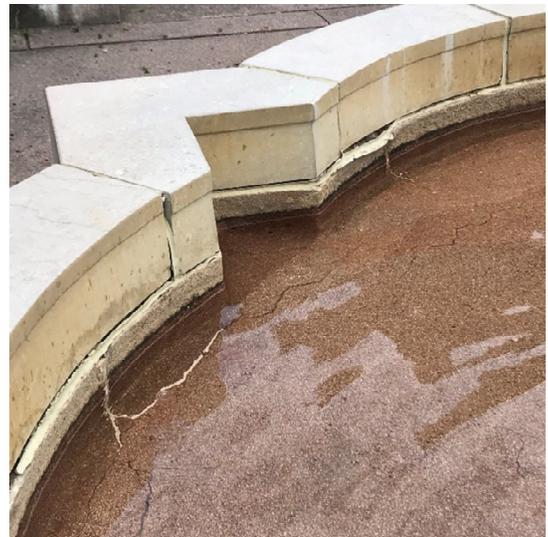
Figure D – Dethatched Cement Caulking

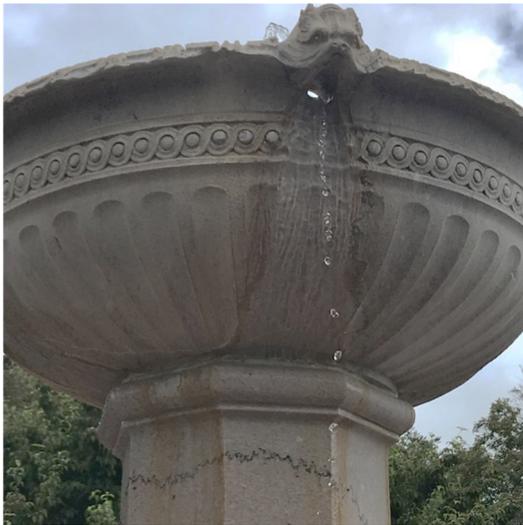
The fountain bowl contains four spouts that are connected to a 1-1/2-inch brass water supply connection. The spouts are set up to discharge water out of four holes situated along the top of the fountain bowl. It is intended for the water to project out of the holes into the basin. Based on scouring on the exterior of the fountain bowl and staining along

the column it is evident that the water does not always properly project away from the centerpiece (See **Figure E**).

Figure E – Scouring & Staining on Fountain Centerpiece

As previously noted, the fountain bowl has significant scouring due to improper projection of water discharging out of the spouts. This has also resulted in staining along the centerpiece column. The fountain water is currently treated with chlorine which is most likely contributing to the corrosion of the fountain bowl as well. The exterior finish of the fountain basin is in fair condition with minor cracks and some discoloration.

It is recommended that the chlorine disinfectant is replaced with an Ultra Violet (UV) to improve disinfection of the filtered water and reduce corrosion of the marble. UV systems allow for the

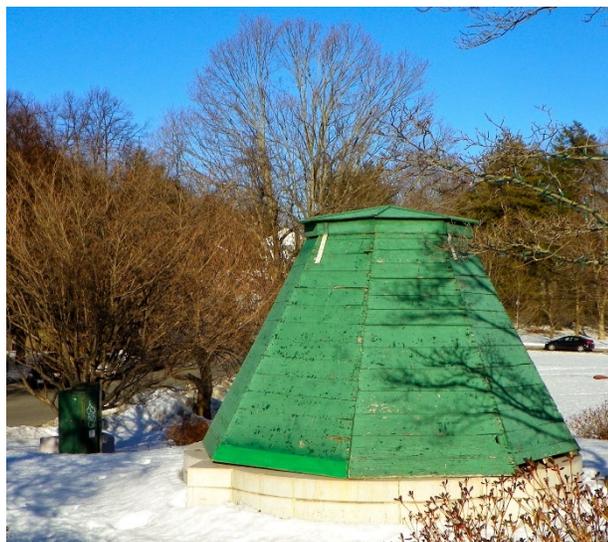
The fountain is currently protected in the winter with wood panels (See **Figure F**). The Town noted that this form of winterization is not ideal. Not only is it labor intensive for the Town to construct and deconstruct each year, but it is also not an effective method in preserving the fountain. Being many pieces, the wood paneling does not create a tight seal around the fountain. Early on cracking can most likely be attributed to this current method of winterization. This form of winterization is also not cost effective as the paneling corrodes easily and needs to be replaced frequently.

Figure F – Current Fountain Winterization Method

Additionally, it is recommended that the method of winterization for the fountain be updated to avoid cracking of the new structure during the freeze-thaw cycle. For winter protect, a possible solution could be a panelized system on a light weight aluminum with a fabric roof.

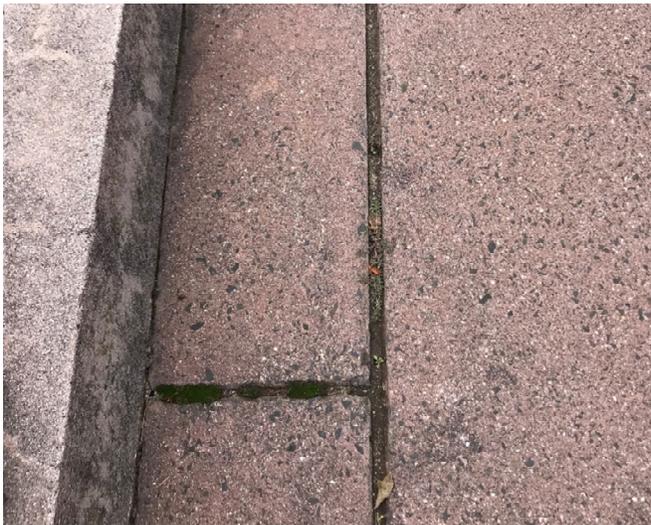
The structural condition of the fountain patio is good. The cement grouting between the concrete pavers has diminished allowing for dirt and weeds to accumulate (See **Figure H**). The finish on the eastern stairs has deteriorated, exposing the concrete (See **Figure I**).

The red pavers that make up the patio have faded significantly over the years. There is also significant discoloration on the pavers and the curbing due to dirt build up over the years. The finishes on the walkway are in good condition. The finish on the eastern stairs has worn and is in need of repair.

Figure H – Fountain Patio Finishes

The fountain patio overall is in good condition and therefore replacement of the patio is not needed. It is recommended that the stairs on the east side of the patio are replaced. The patio should be power washed regularly to remove buildup dirt and weed growth on and between the pavers. This will help improve the appearance of the patio. It could be beneficial to install lighting around the fountain since the fountain runs overnight.

Since the color of the pavers has significantly faded the Town should consider replacing the pavers as part of the fountain replacement. This will improve the overall appearance of the fountain.

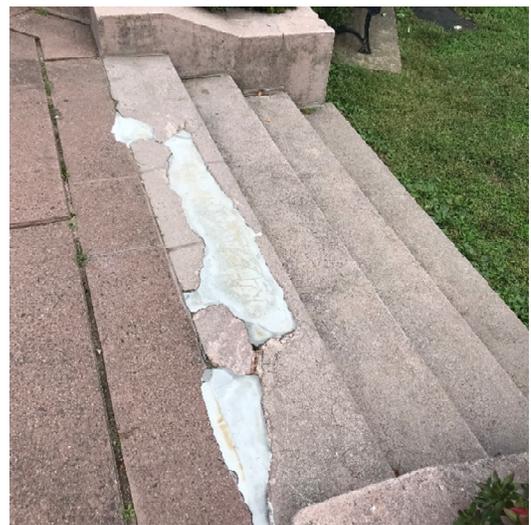
Figure I – Eastern Stairs

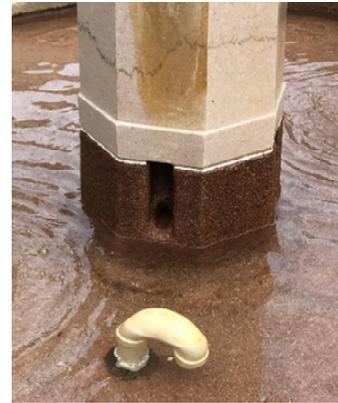
The Fountain was designed to have water enter the filtration system from the fountain basin through the four 3/4-in inlets in the base of the center column. Due to cracks and openings within the fountain coping and veneer the water level has been kept low below these inlets. To accommodate the low water depths the fountain was reconfigured to utilize the existing drain for filtration.

As shown in **Figure J** the drain is currently a 4-in PVC pipe installed in the basin floor. Water collected through this pipe is typically gravity fed to the collector tank. When the fountain basin needs to be drained the water is redirected to the Town's sanitary system through the opening and closing of valves.

Figure J – 3/4-in PVC Inlet

The equipment for the recirculation system was recently updated and appears to be in good condition. No pressure testing was performed on the piping and therefore the piping should be replaced as part of the fountain restoration. It is recommended that the fountain and fountain patio be replaced in conjunction with replacing the piping. As mentioned in Section 3.0 Evaluation of Existing Fountain Patio, the concrete panels of the patio have faded significantly, and therefore new concrete panels would improve the aesthetics of the fountain.
