North Amherst Library South Wall Repair

October 2020

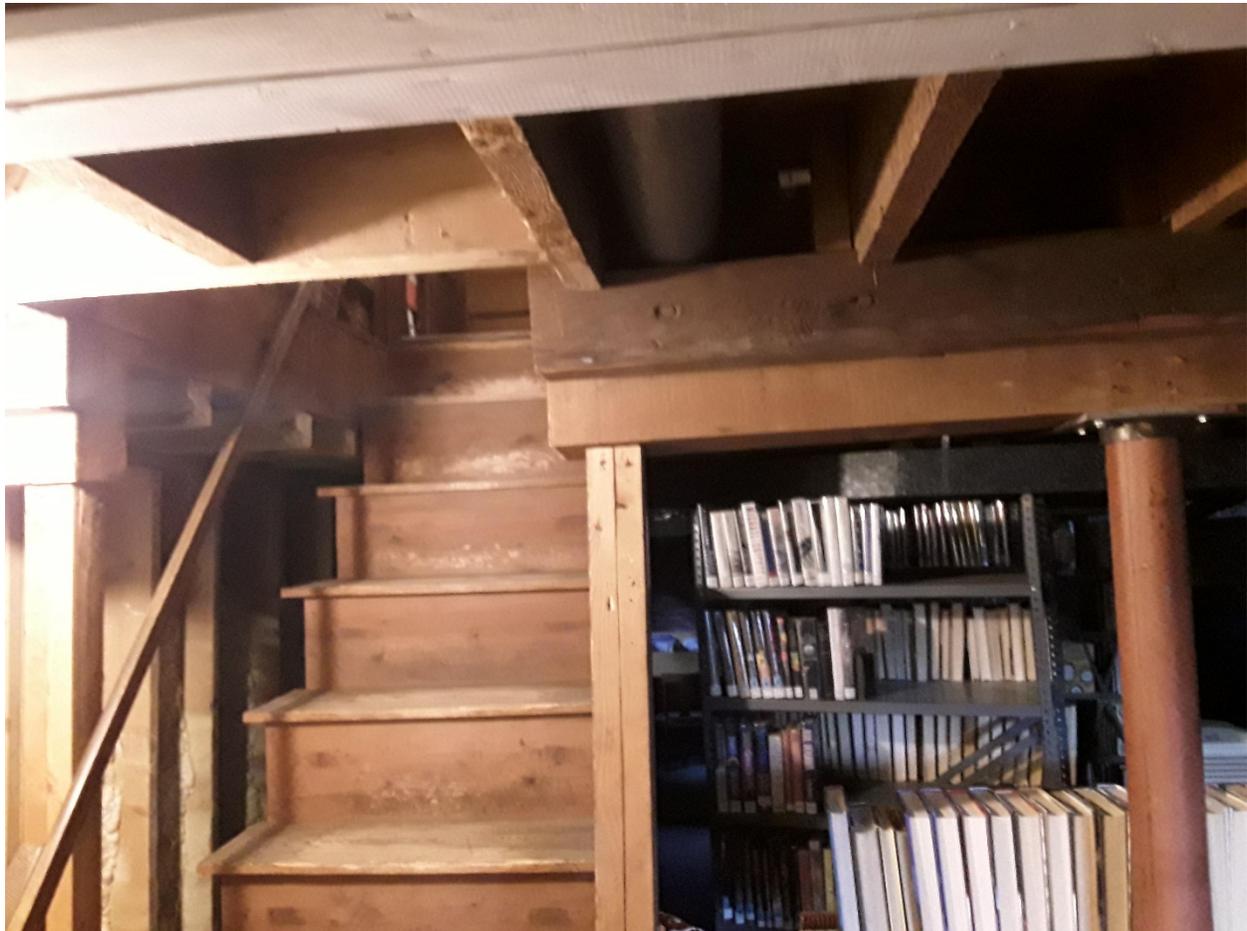
Picture #1

The next three pictures show the where the first floor support beam has been cut to install stairs from the first floor to the basement. Previous access to the basement was from the outside with no connection to the first floor.

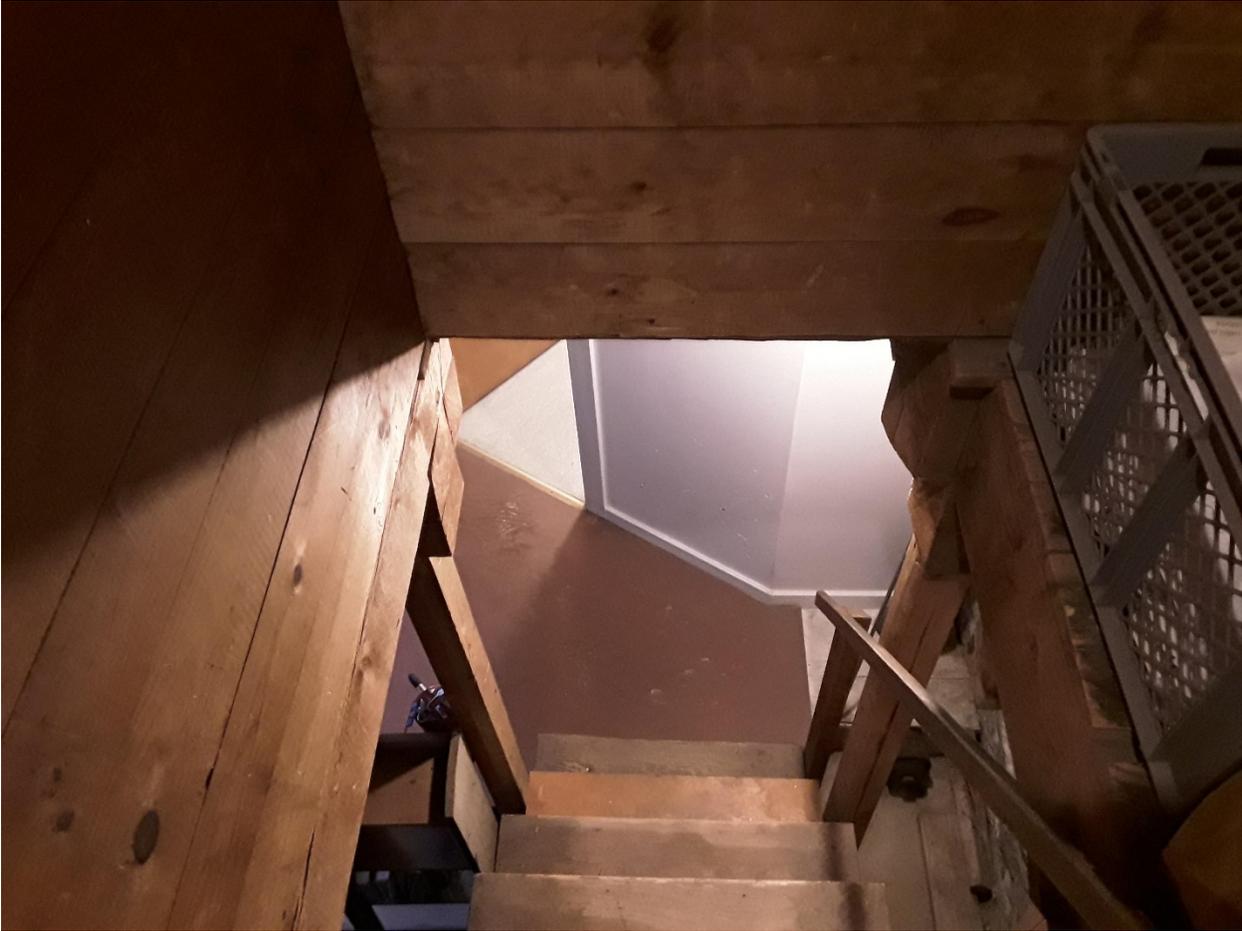
Picture #2. There should be 2 floor joist in this space resting on the support beam. The beam section and floor joist were removed for the stairs.
