Documentation of Restorations to 1870 section of West St Cemetery, Amherst

MONUMENT CONSERVATION COLLABORATIVE LLC, NORFOLK, CT

STONE CONSERVATION TREATMENTS West Cemetery Amherst MA

July 2018

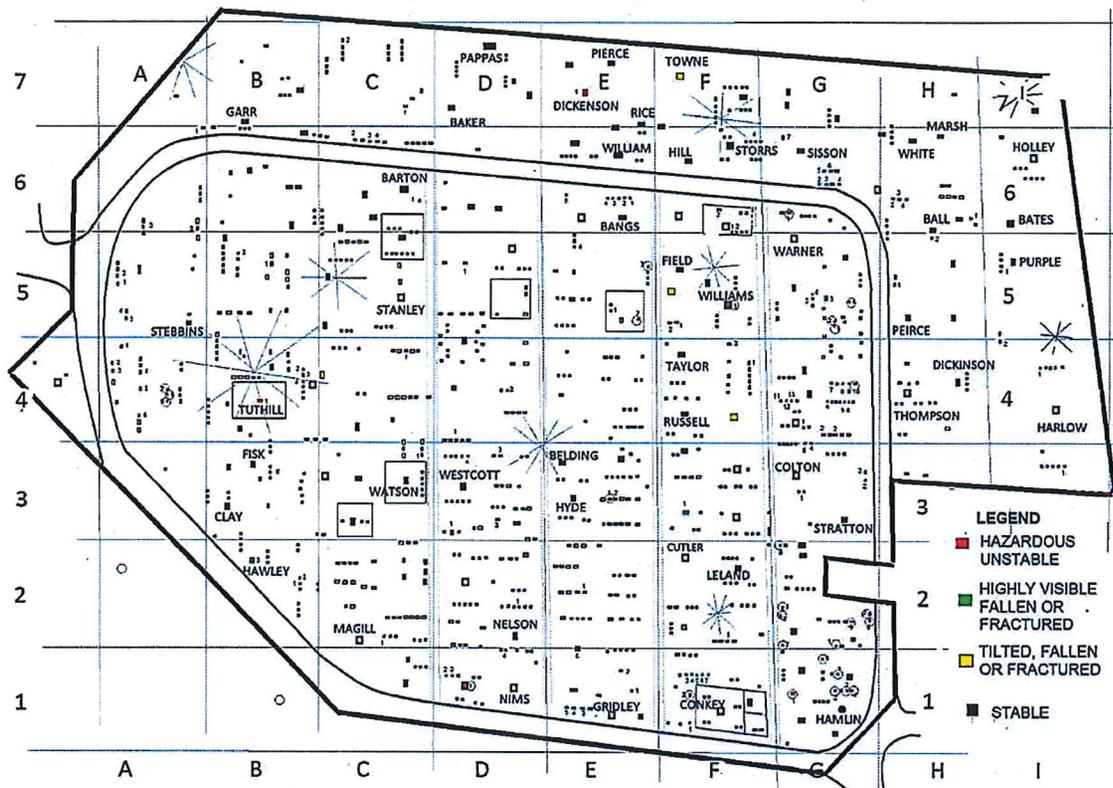
Approximate location of markers

At the meeting the Historical Commission and the Senior Planner agreed that these 28 should be listed as "priority 1" and are circled in red on the attached map

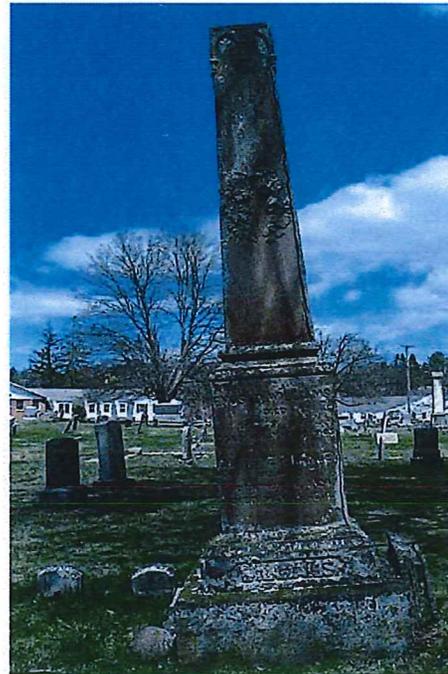
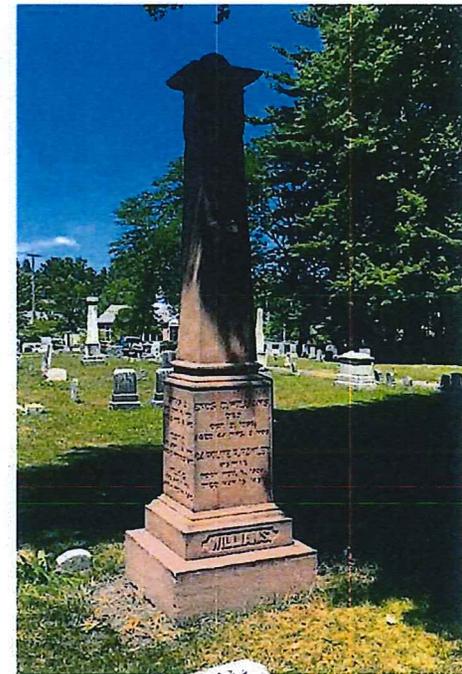
Before and after cleaning

Removal of biofilm was with D/2 Biological Solution. It is an aqueous antibacterial solution that also aids in the removal of algae, fungi and other organisms. After application and scrubbing with soft brushes, surfaces are fully rinsed with water. Stubborn, well-attached growths will slowly release their grip in a short amount of time and the stone will appear cleaner.

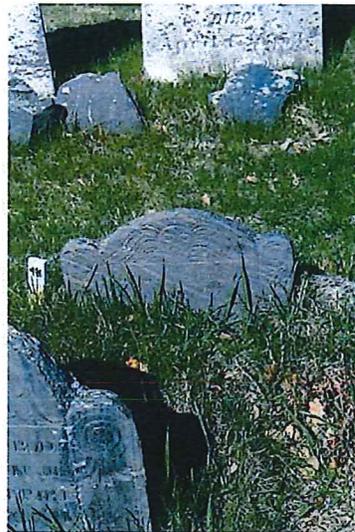
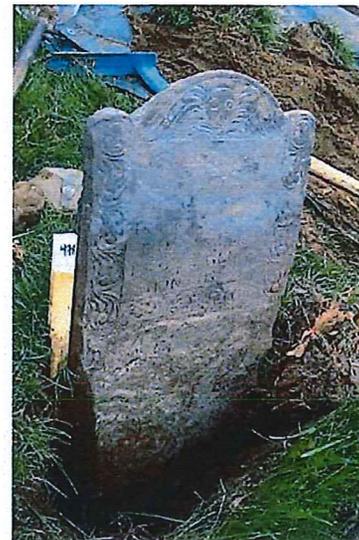
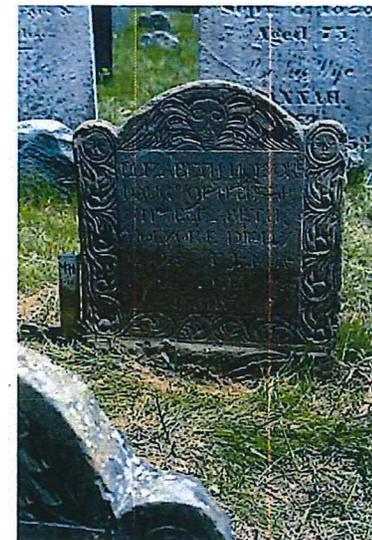
18th century markers often have as much below the ground as above. Upon excavating this marker for resetting the very massive below grade portion becomes apparent..

Earlier gravestones are typically long panels of stone that were set directly into the ground. After determination of the correct location and orientation of the stone, soil was removed to an appropriate depth. Gravel (or broken stone) was introduced to establish a stable base. The stone was made plumb and level, and set in plane with the adjacent markers. Backfilling was done with sand and gravel, wetted and compacted. Every effort was to replace disturbed areas with existing topsoil and turf, however additional topsoil was required at a number of sites.

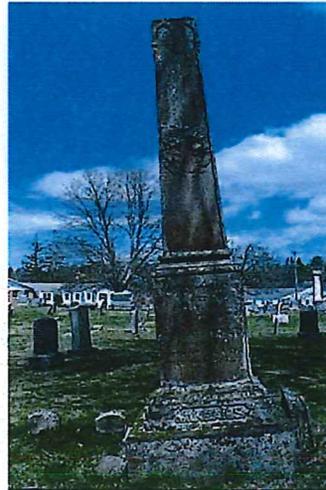
F5.3 Williams Obelisk

Older large monuments, such as the Williams Obelisk monument, are typically set on a deep bed of dry laid stones. At times these stones will shift due to ground conditions; sometimes due to burrowing animals, frost heaves, flooding, etc. causing the monument to tilt and become unstable.

At a certain angle they become hazardous to themselves, adjacent stones, and to bystanders.

Using cranes or hydraulic jacks to lift these substantial monuments, the base is stabilized and set level. If required, individual elements are separated and reset onto a mortar bed.

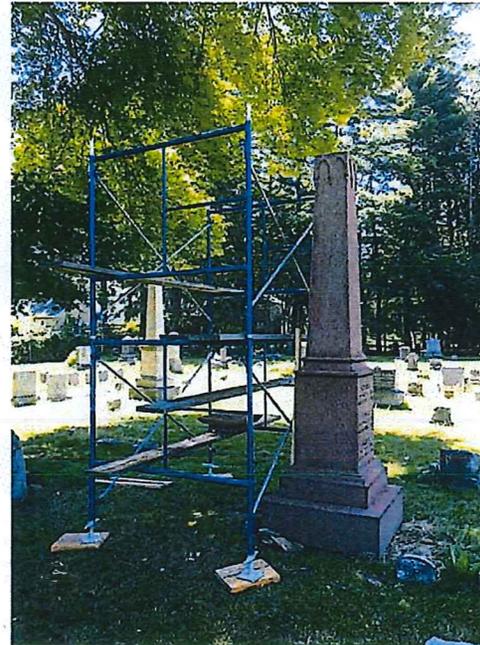
Scaffolding was used to help aid resetting the upper elements

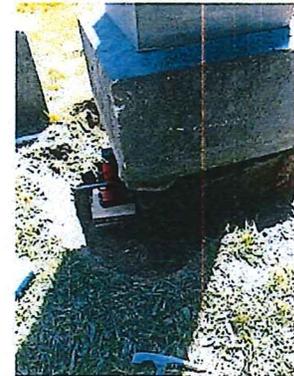
Example of leveling the base with hydraulic jacks.

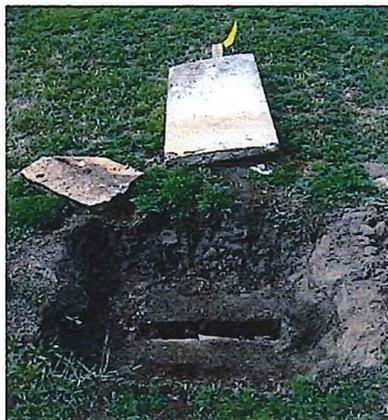
When excavating for resetting often original, or old bases are discovered

In many cases, fallen markers had been originally set into below grade sandstone bases. When discovered, these bases were often uncommonly deep, more than one foot. Bases were excavated, examined for soundness and reset level at a higher elevation and aligned with adjacent markers.

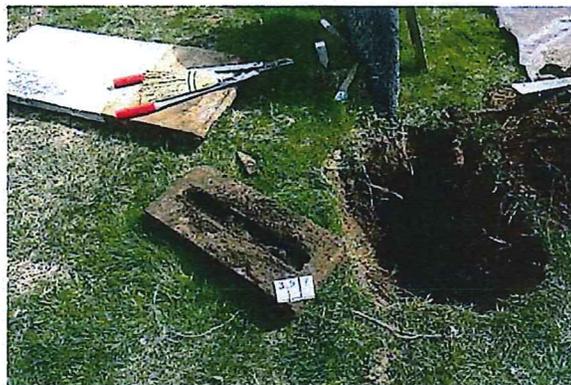
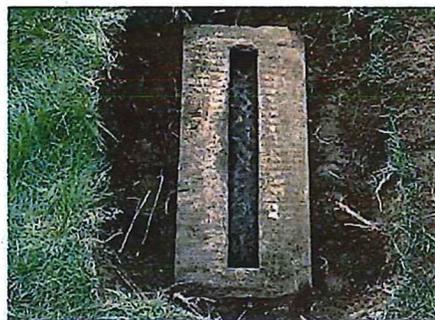
Old base reset higher and aligned with adjacent markers

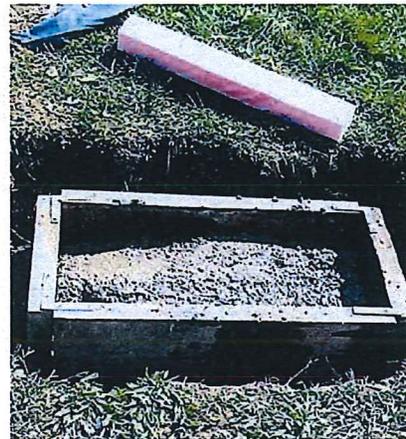
Form for new below grade concrete base

Bases were made on site by casting in place with concrete. The casting is generally 9 to 12 inches deep, and 6 inches greater in both thickness and width than the stone itself. The finished top surface of the base should be entirely below grade. A form for a 1 inch deep setting slot, ½ inch wider and ½ thicker than the stone, was positioned in the concrete. After the base cured, the gravestone was reset into the slot with a cement/lime-based grout as previously described. The top of the new base was covered with topsoil.

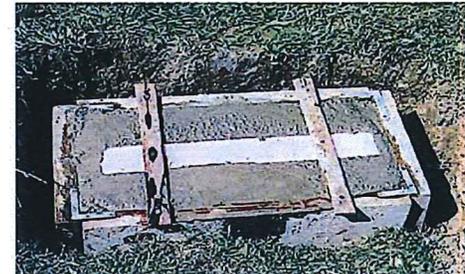
Concrete poured, with form for setting slot in place

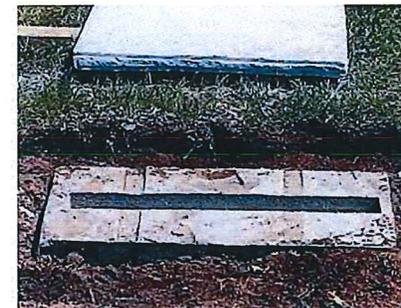
Form removed, ready for resetting marker

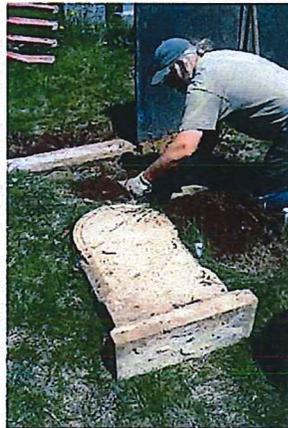
Discovering and excavating existing base.

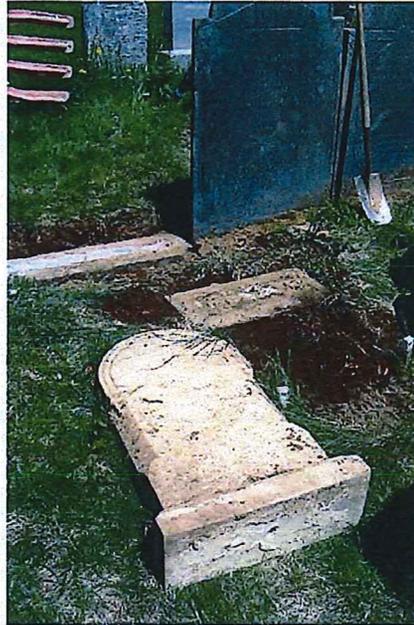
Raising and re-setting base

For resetting onto existing bases or ledgers, setting surfaces were first primed with Acryl 60 diluted with water 1:3, and markers were reset with a cement/lime-based grout (3:2:9:1) with fine aggregates (000).

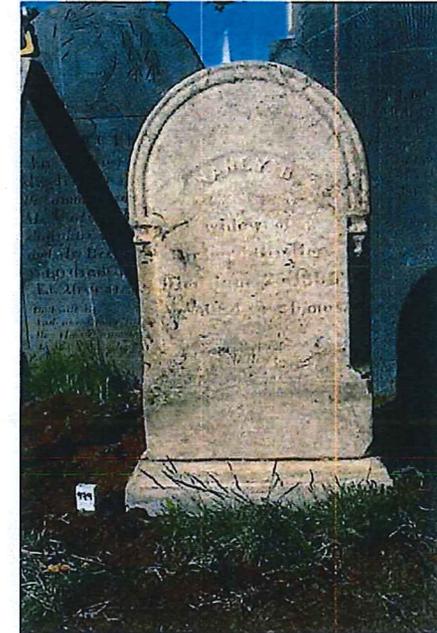
Marker securely reset onto base

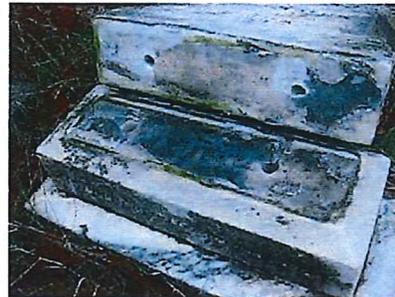
Loose pins are easily removed by hand and replaced with threaded stainless steel.

Existing pins were inspected and if sound, were re-used. If missing or unsound they were removed by drilling around them with a core drill and replaced with stainless steel threaded rods. Setting holes were drilled to clean out debris.

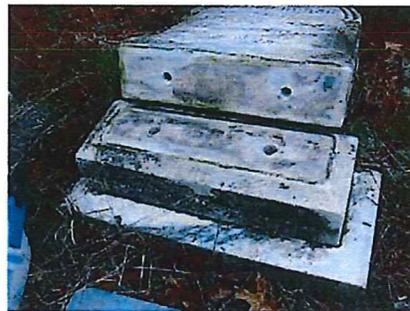
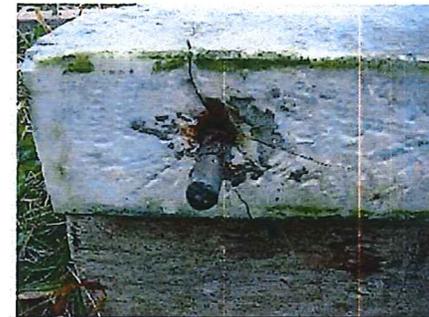
Below: failed setting mortar removed from setting surfaces and areas treated with antimicrobial D/2

Above: Example of cracking cause by rusted pin.

Any remaining failed setting mortar or material is removed by hand and the setting surfaces treated with D/2 Biological Solution.

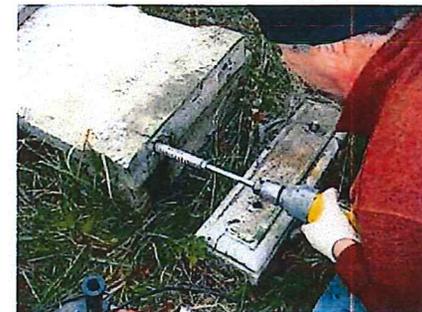
Below: Iron pins removed with core drill, replaced with threaded stainless steel.

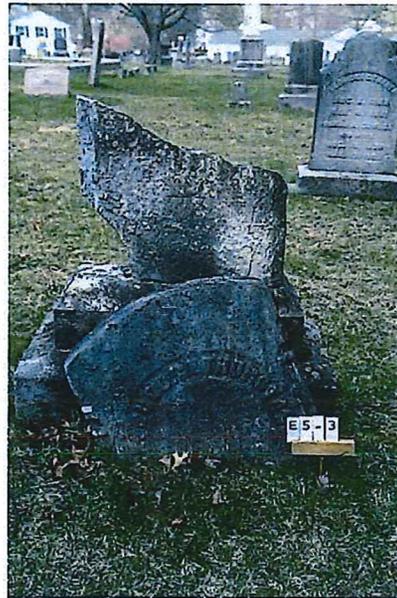
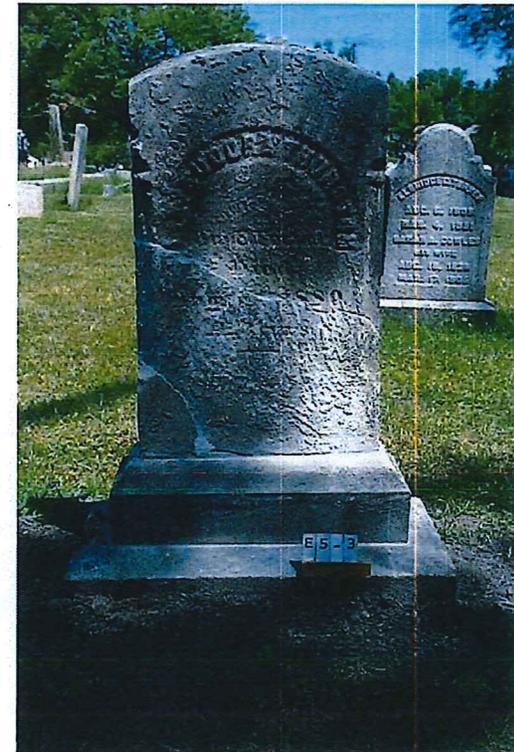
Example of structural adhesion

All fragments were carefully cleaned and dry fitted. A thixotropic, thermosetting structural resin (A-5522, by Abatron, Kenosha, WI or equivalent) was thinly and evenly applied along the bond line only. The fragments were aligned, joined with clamps, and adequately braced during curing, which was typically a period of several days.

Several factors, including weathering, can result in a loss of stone surface, which results in a poor 'fit' at the fracture. In this instance, a structural fill (mix of structural resin and fine aggregates) was required in addition to the structural adhesive. The fill was tucked into any voids of the fracture, but was kept well back from the surface of the stone. After curing, the structural fill was concealed by installation of an appropriately colored cement/lime-based crack filler or restoration mortar (see "Cracks and Losses").

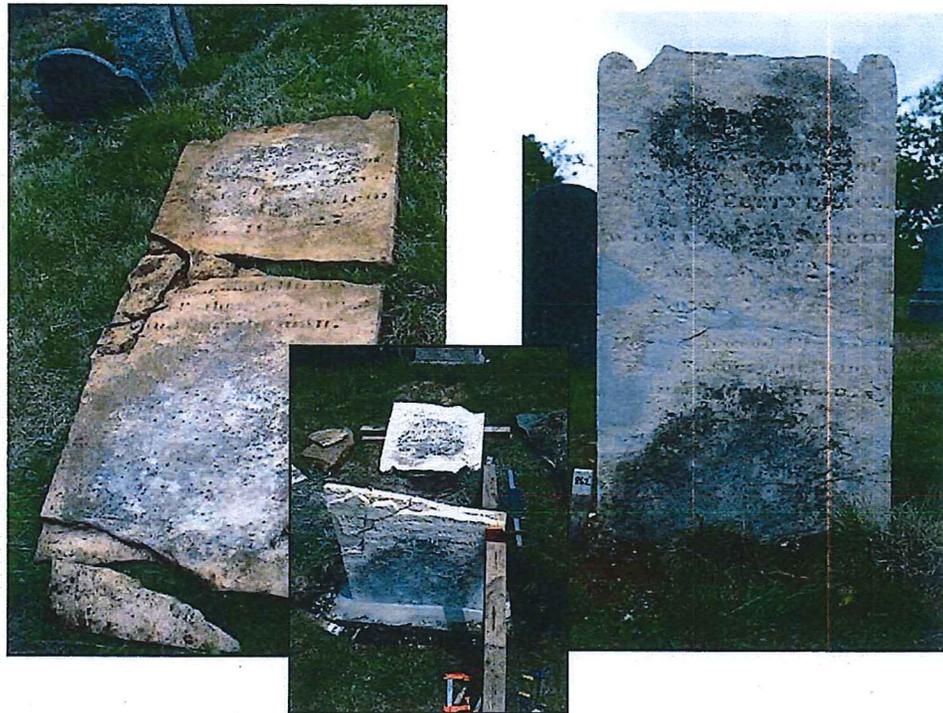
*Example of fractured marker with fills, Before and After
After structural adhesion, losses were filled with Jahn M-70 and M-110
pigmented mortar*

Fine cracks were filled with an integrally colored cement/lime-based formulation (RepliCal™ Crack Filler. Larger areas of loss were filled with either Jahn™ M-70, or M-110 Restoration Mortars or with RepliCal™ a cementitious repair composite designed to match weathered surfaces. For marbles, RepliCal contains specially sized and graded marble aggregates.

After partial curing, the fills were treated with a light acid washing with 5% acetic acid. This final treatment removes any cement or lime from the surface of the filled area and exposes the aggregates of the mix. All treated areas were thoroughly rinsed with water.
