Enos Cook Memorial Fountain Assessment Report

Town of Amherst
Sweetser Park
Amherst, MA 01002

November 2018

ENGINEER'S REPORT

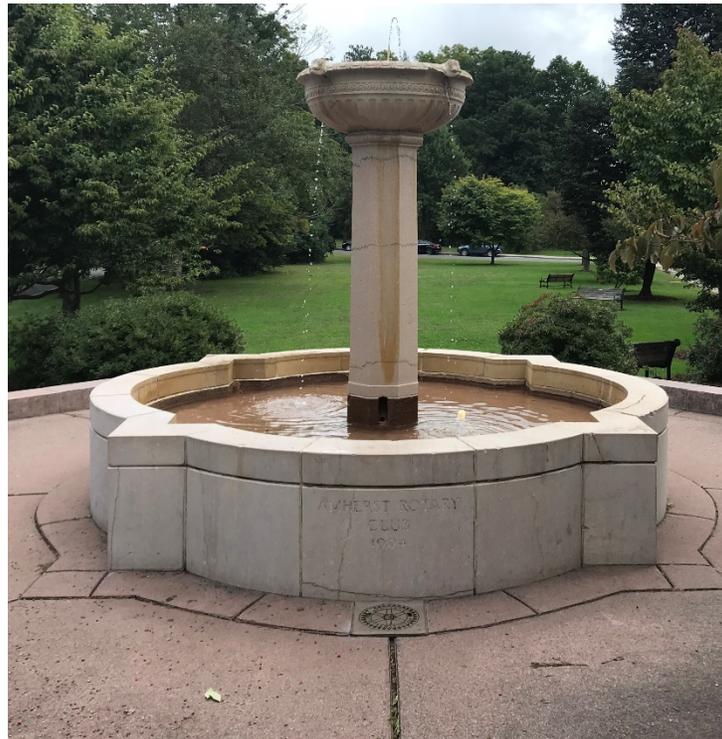
Figure G – Fountain Patio Looking East

The fountain is bordered by a concrete patio with red pavestones, shaped to outline the fountain (See **Figure G**). The outside border of the patio has a 1-ft 2-in wide by 9-in high concrete curbing. The patio has four openings, one to the North, South, West, and East of the fountain. At the East opening there are stairs extending into green space and to the North, South, and West openings are ADA compliant walkways. The northern walkway extends approximately 345-ft towards Lessey Street and is made up of grey brick pavers set on a concrete deck with a granite border. The southern walkway extends approximately 50-ft towards Main Street and is constructed of cement concrete. The western walkway extends approximately 85-ft towards Boltwood Walk and is made up of red brick pavers.

The structural condition of the fountain patio is good. The cement grouting between the concrete pavers has diminished allowing for dirt and weeds to accumulate (See **Figure H**). The finish on the eastern stairs has deteriorated, exposing the concrete (See **Figure I**).

The red pavers that make up the patio have faded significantly over the years. There is also significant discoloration on the pavers and the curbing due to dirt build up over the years. The finishes on the walkway are in good condition. The finish on the eastern stairs has worn and is in need of repair.
